CORN MILLS OF PENRHYN LLŶN

John Crompton

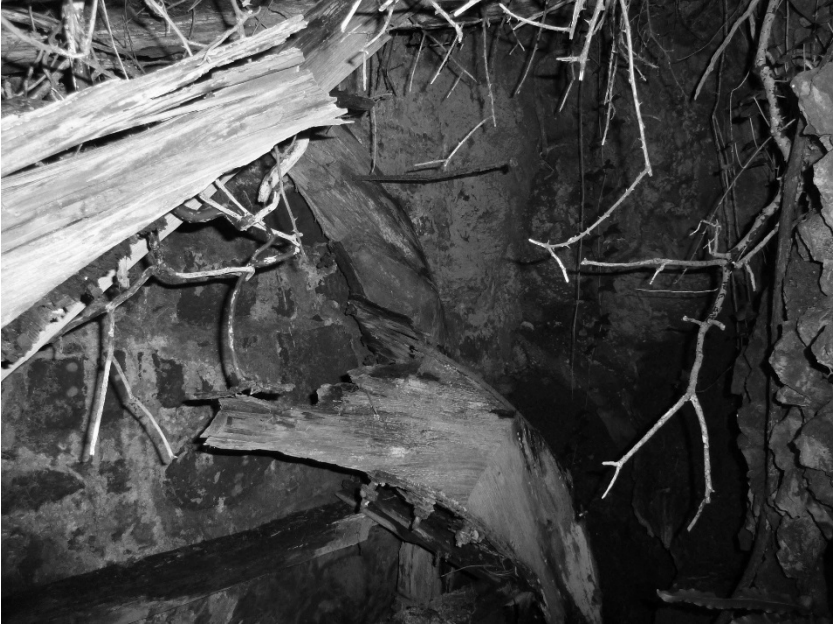
3 Melin Bodwrdda SH1894327368 NPRN 411334

This later building still stands and is maintained in good condition as a store. The two-storey rubblestone mill building has lost its roof and floor and its interior is inaccessible. In the wheelpit at the east end are the remains of the waterwheel, 14ft (4.27 metres) x 33 inches (0.84 metres) wide, with eight pairs of wooden spokes set in cast iron hubs on a square cast iron axle, and wooden shrouds grooved to hold the bucket boards. Next to the wheelpit is a brick-built foundation for a turbine. Inside the mill, the badly-worn cast pitwheel, in situ under the collapsing hurstframe, can be seen through a small ventilation opening in the south wall.

PLATE 1 Wooden Shrouds from the Wheel at Melin Bodwrdda

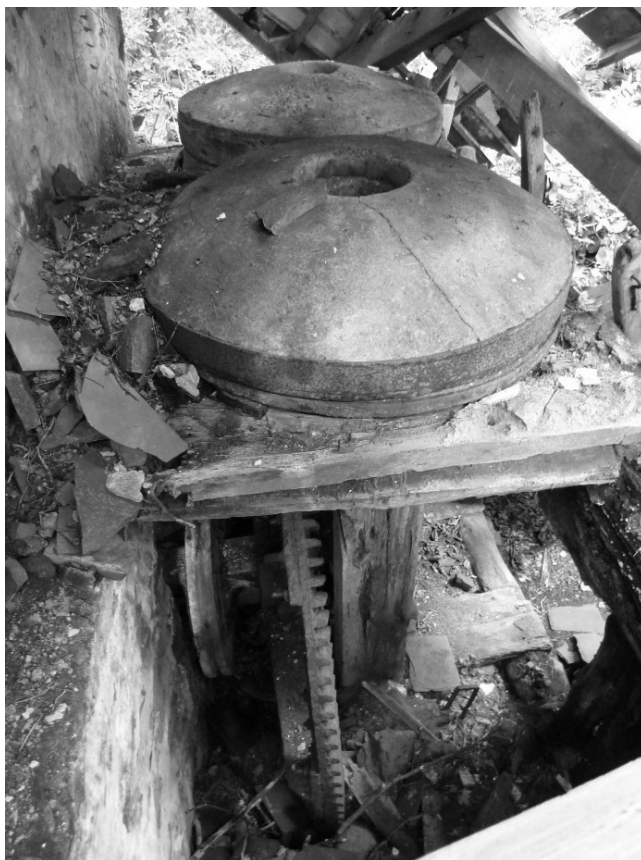
6 Melin Trygarn SH2351731764 NPRN 411401

Melin Trygarn is named as a working corn mill on all three editions of the 25-inch O. S. map. The south east side of the two-storey building was built into the valley side. The north-east gable of the rectangular building has collapsed and the roof has fallen whilst retaining its structure; most of the upper floor has collapsed.

Above and to the south of the mill there is a carefully walled millpond, dry but in good condition. A carefully constructed leat led to a wooden launder, which has disappeared, over the overshot wheel on the south west gable. The wheel is 17ft (5.2 metres) in diameter and 34 inches (0.86 metres) wide; there are no buckets but the shrouds are intact though leaning over as many of the wooden spokes have rotted away. The 7-inch (0.18 metres) square cast iron axle carried a cast iron pitwheel which originally drove only one pair of stones, but a horizontal drive and second, smaller pair of bevel gears has been added to drive a second pair. The stone nuts have wooden teeth. The two

pairs of monolithic stones are still in situ on the hurst frame, the only part of the upper floor remaining. A separate building to the east housed a drying kiln, with ceramic kiln tiles carried on slate beams over a hopper structure formed of heavy stone slabs.

PLATE 2 Machinery in the collapsed Melin Trygarn

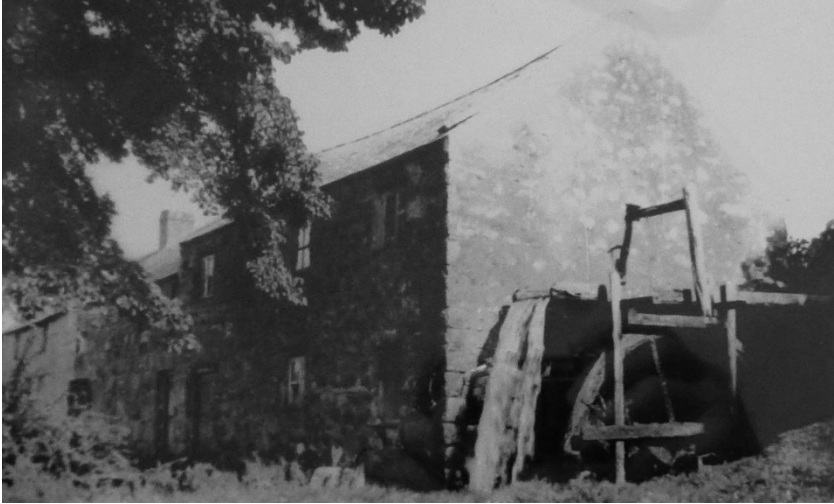
15 Melin Cefn-Llanfair SH3268933492 NPRN 411682

Melin Cefn-Llanfair is named as a working corn mill on all three editions of the historic 25-inch O. S. maps. The mill was at the south-east end of a linear range of buildings, all now converted to a single dwelling. The overshot waterwheel was on the south-east gable fed by a 1350 metres-long leat and a wooden launder supported by a timber gantry; it was probably about 12ft (3.66 metres) in diameter. The original door and window openings have been kept, with new frames; an inverted millstone forms the threshold of the wide door, and two others lie close by in the garden. Inside some constructional timbers have been reused, but probably not in their original positions. The section of building next to the mill was the drying kiln, and kiln tiles have been recovered. The functions of the rest of the range have been obscured during its conversion.

PLATE 3 Melin Cefn-Llanfair from an old photograph
