# COED TREWERNAU MILL: THE WORKING PARTS

Alan Stoyel

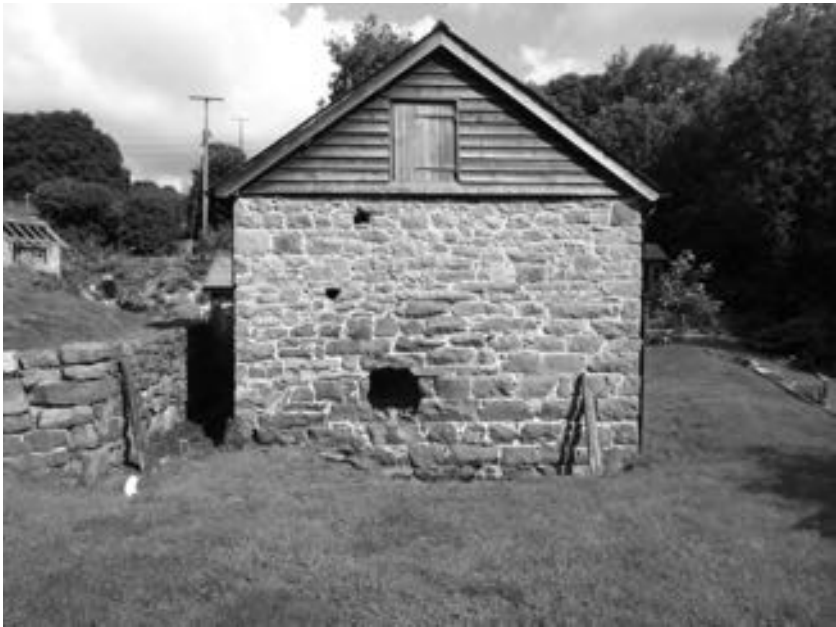
small header pond have been lost, and the former wheel-pit and tailrace had been completely infilled and levelled. There remains a prominent aperture in the 30ins. wall for the wooden wheel-shaft. This shaft-hole is roughly circular, approximately 29ins diameter, but the shaft itself ends within the building, the external part completely rotted away or removed (Plate 1). Several feet above this is a recess which once accommodated a beam supporting the pentrough.

PLATE 1 The end wall, showing the shaft-hole for the waterwheel and positions of the trough support and water control to the wheel

A vertical measurement between the top of this cavity and the approximate centre of the hole for the wheel-shaft indicated there had been a waterwheel, probably overshot, of about 10ft.

diameter. A wheel any larger than this could not have been accommodated because of the level of the stream into which the short tail-race once discharged. A third aperture, high on the same end wall, was for the shaft controlling the water supply to the wheel, this having been operated from the stone floor of the mill (Plate 1).

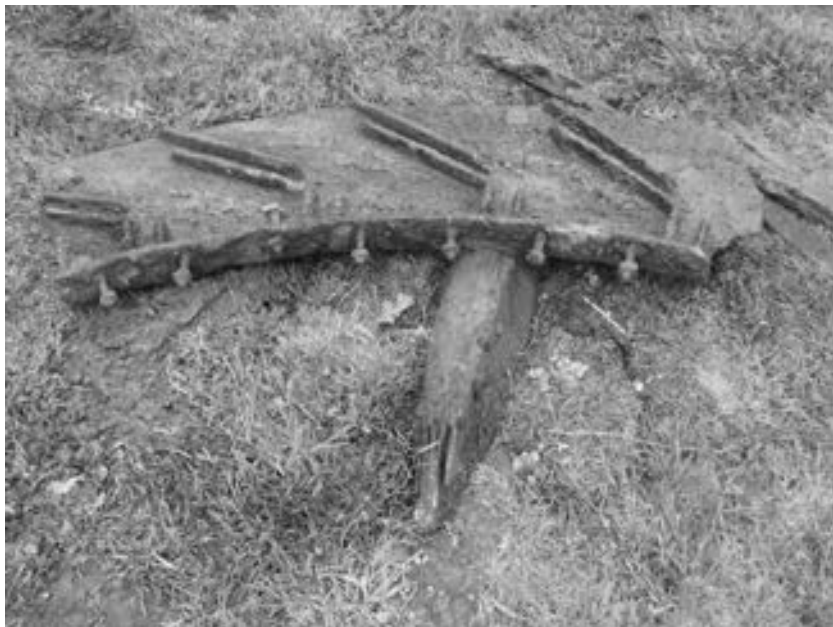
An excavation of the central part of the former waterwheel pit<sup>5</sup> yielded two pieces of cast-iron shroud of the wheel. The curvature of the outer edge of the larger piece confirms the diameter of the wheel as being 10ft. The cast shroud is plain, and 12ins. deep, including the flanges to accommodate the wooden sole-boards. Part of the 5¼ by 3¼ins. oak arm is still attached to the external face of the larger shroud fragment by two bolts with 1½in. square heads (Plate 2).

PLATE 2 Larger fragment of waterwheel shroud from excavation

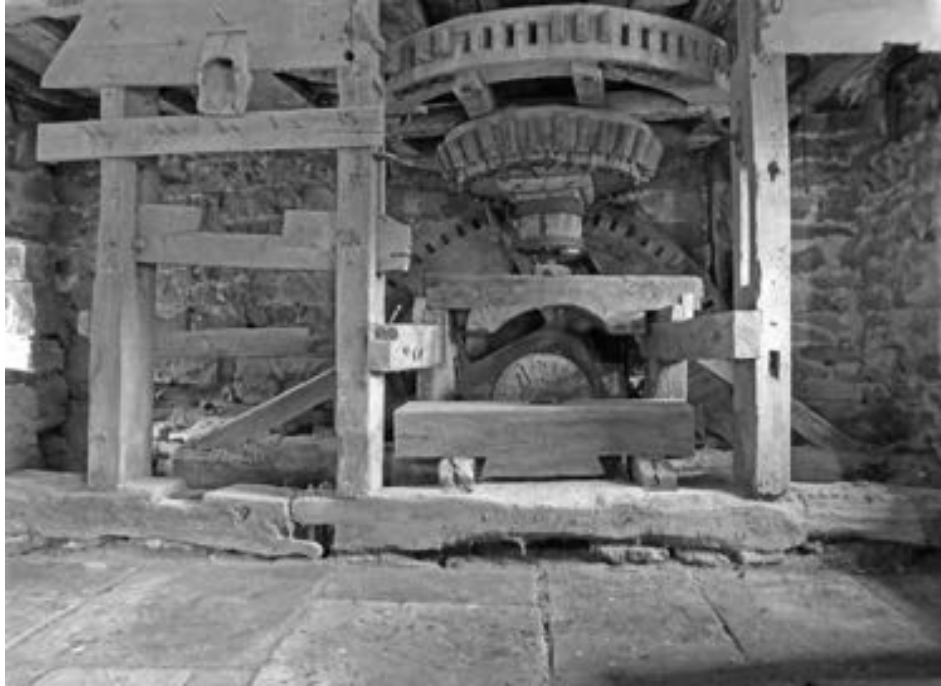
Inside the mill the working parts are almost complete. The gear is of the standard, two-step under-driven type with two pairs of stones on a hurst which is level with the stone-floor (Plate 3). The metalwork has been stripped, so the damsels, spindles and their associated footstep bearings are missing, as are the water control lever and shaft.

PLATE 3 General view of hurst and pitgear

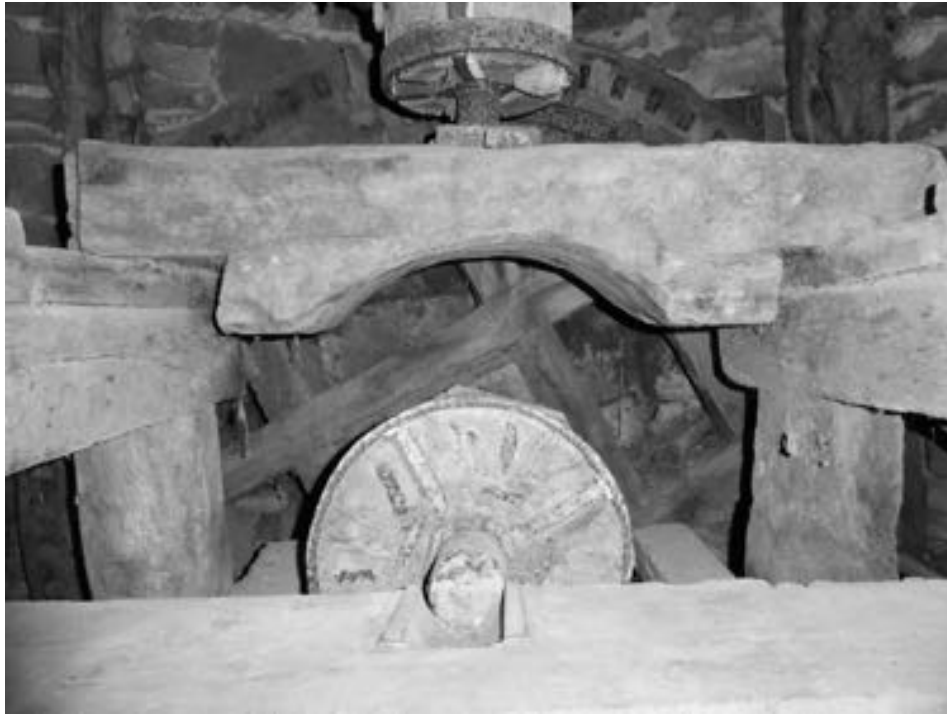
Within the mill the wheel-shaft, presumably of oak, is in good condition, although the outer, rotted, end has dropped out of position. The shaft is octagonal, 16ins. across the faces, and 16ins. square where it carries the pitwheel. The inner bearing has two gudgeon rings holding a cross-tailed gudgeon with a pintle  $4\frac{1}{2}$ ins. long and 3ins. in diameter (Plate 4).

PLATE 4 The inner bearing of the wheel-shaft with the sprattle beam supporting the upright shaft

diameter, elsewhere. The base of the shaft is fitted with a cross-tailed gudgeon clasped by two iron rings, with a  $2\frac{3}{8}$ ins. diameter pintle (Plates 4 & 5). The shaft is supported by an arched wooden sprattle-beam which forms part of a timber frame. The timbers for the upper bearing are particularly crude, and are incorporated in the flooring between the millstones (Plate 6).

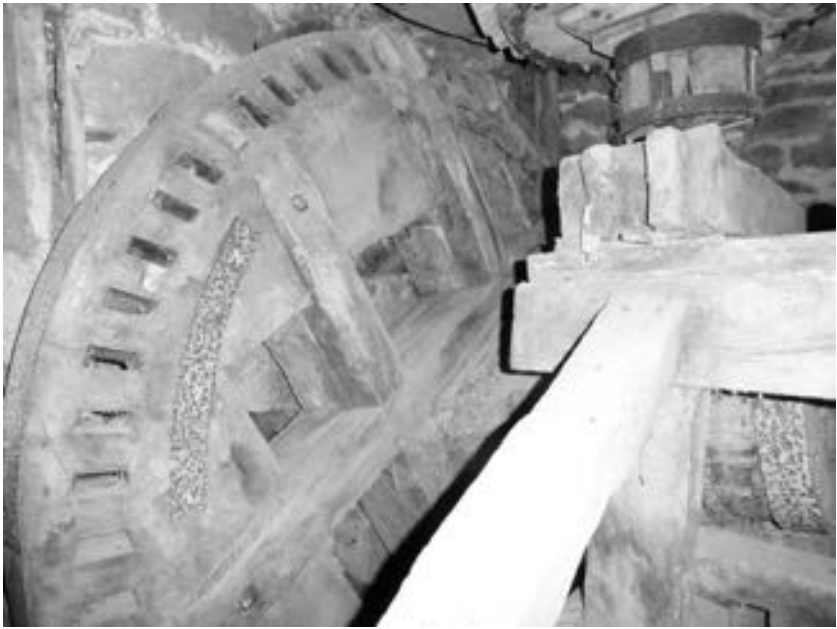
The very fine wooden clasp-armed pitwheel, 7ft. 3ins. in diameter, (Plate 5) is also in good condition, except for the lowest quarter which has rotted away completely. The thickness of the wheel at the perimeter is  $4\frac{1}{2}$ ins., and the oak arms are approximately  $11\frac{1}{2}$  by  $4\frac{1}{2}$ ins, each comprising two baulks of timber. The face of the wheel is bevelled and once had 68 oak cogs of 4ins. pitch,  $3\frac{1}{2}$ ins. face and 2ins. projection, but most of these are now missing.

PLATE 5 The clasp-armed wooden pitwheel

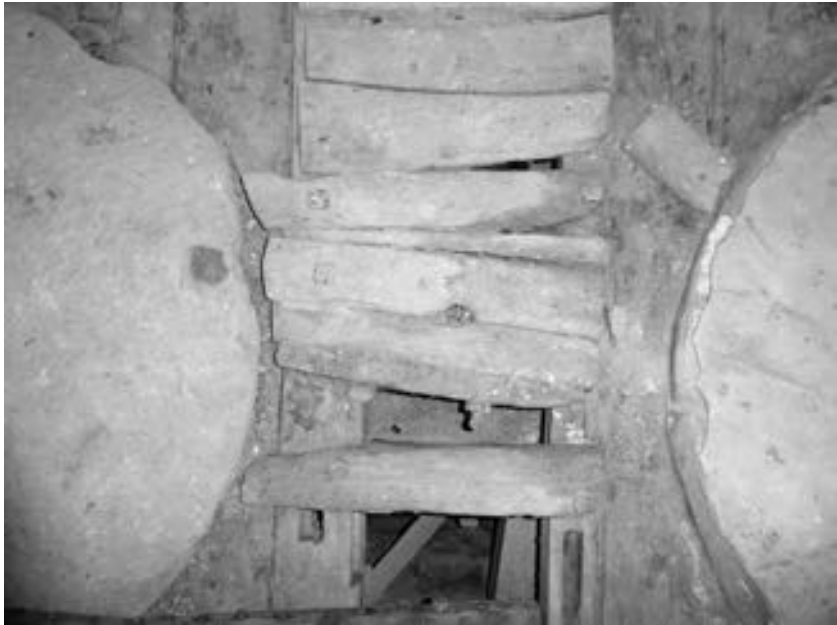
PLATE 6 The timbering supporting the top of the upright shaft, from above. The bedstone is on the right-hand side

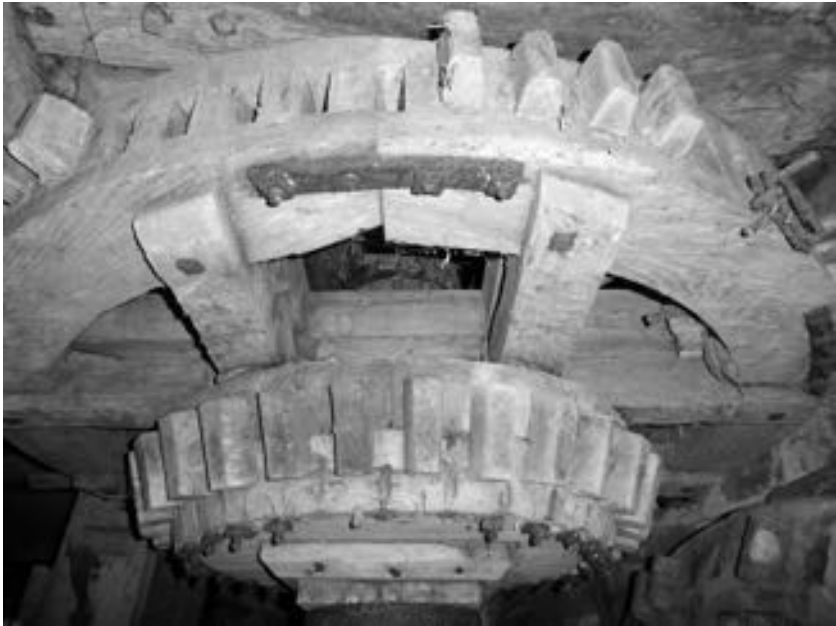
The solid wooden wallower is of elm and was constructed in four pieces (Plates 7 & 8). There are two joined semi-circular blocks both above and below a continuous median horizontal parting. The two joints holding the semi-circular blocks are

PLATE 7 The spurwheel and wallower

The fine wooden clasp-armed spurwheel has oak arms and elm cants (Plate 7). Each arm is made up of two baulks of timber, each  $3\frac{1}{2}$ -4ins. square. It had 68 cogs of fruit-wood, probably apple, although most of these have been removed. They have a pitch of  $3\frac{1}{4}$ ins., a face of  $3\frac{1}{2}$ ins. and a projection of 2ins.

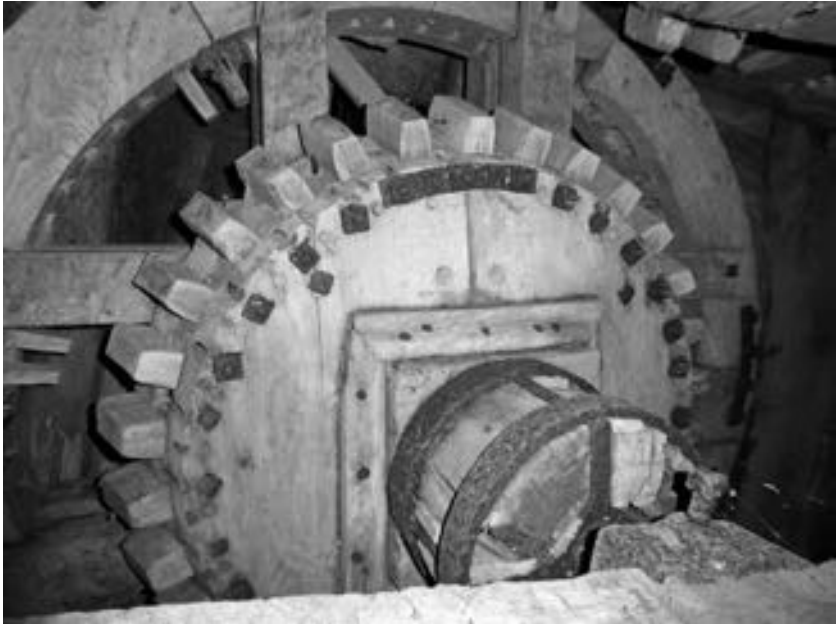
Midway between the shank pegs in the wallower is a series of vertical coach bolts with square nuts which are mostly at the lower end. An interesting and very significant feature of this

gear is that the series of iron coach bolts has been moved towards the centre by  $1\frac{1}{2}$ ins., and an extra ring of wooden cog-shank pegs has been added, similarly displaced inwards by 1in., leaving remnants of the earlier pegs in place (see under Discussion).

PLATE 8 The wallower from below

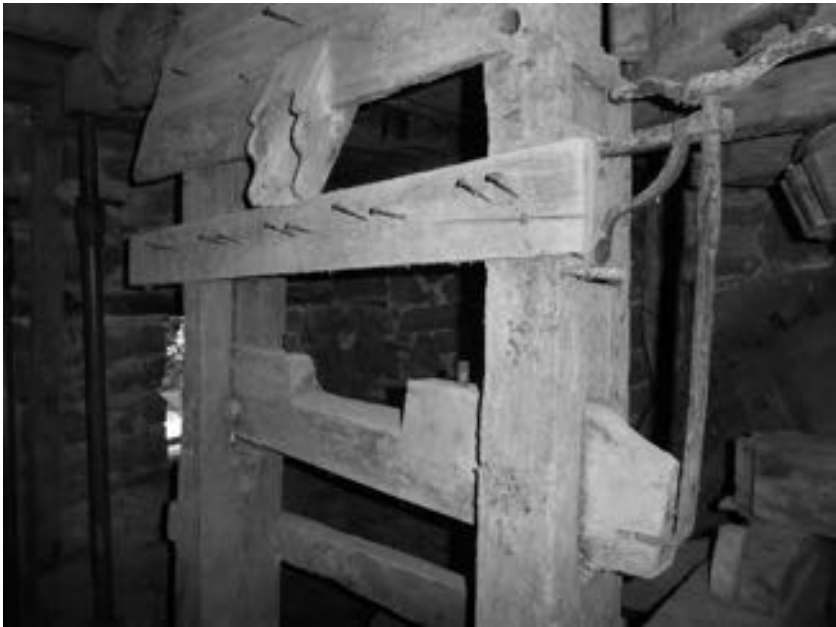
PLATE 9 The front bridge-posts of the downstream pair of stones with brayer and tentering control

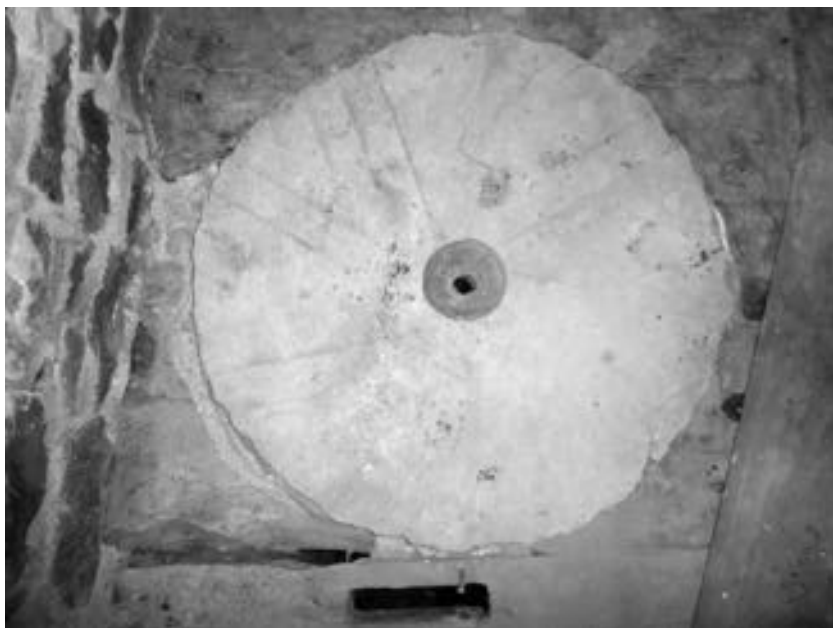
Of the millstones, the downstream bedstone is still in position, and is a domed conglomeratic grit stone, 4ft. 2ins. in diameter, dressed for clockwise rotation, with 9 harps of 4 furrows. It is interesting that it still has its wooden eye (Plate 10). The rotation direction of this stone indicates that the waterwheel was overshot, as distinct from pitchback or high-breast. The runner stone is missing. Between the two pairs of stones, incorporated in the floor, is the crude timbering holding the upper bearing of the upright shaft (Plate 6).

PLATE 10 The downstream bedstone with wooden eye

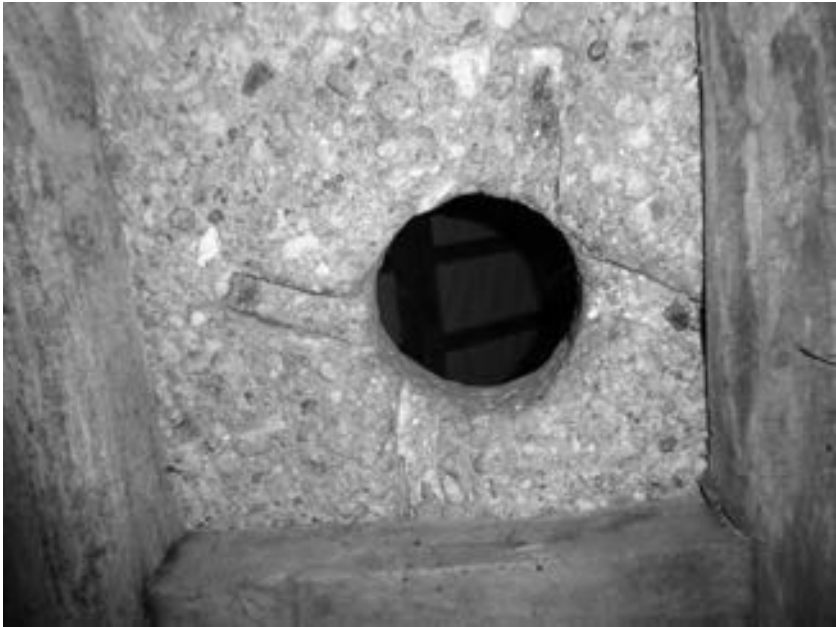
On the upstream side the bedstone is missing, but the runner is roughly in position, facing downwards. It is domed, approximately 4ft 6ins in diameter and of a coarse conglomerate, with mortices for a stiff-rynd (Plate 11). The stone probably came from either the Penallt area of the Forest of Dean or from Anglesey. The lithology of the conglomerate fragments suggest the former. There was no ancillary machinery, for cleaning, dressing or hoisting on this floor.

PLATE 11 The upstream runner stone from below showing rynd recess

The rynd recess in the upstream runner stone (Plate 11) is of an early type. The pattern is between a 'horned' and a cruciform one, and would be appropriate for the early or the middle of the 18th century, and could have come to the mill second-hand.

The rynd mortice seen in the upstream runner stone (Plate 11) is of an early type. The pattern is between a 'horned' and a cruciform one, and would be appropriate for the early to middle of the 18th century. This suggests that it is contemporaneous with the mill building, or that it came here second-hand.

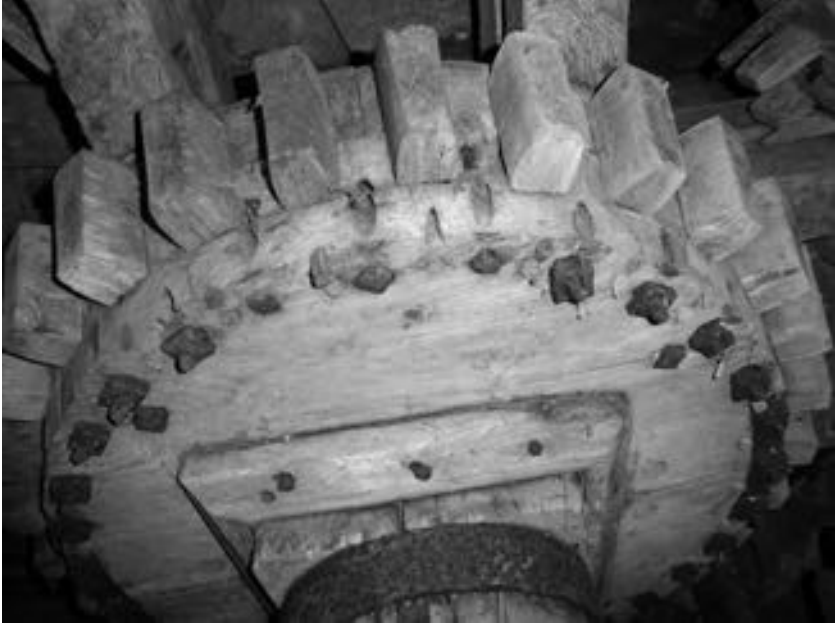
Determination of the age of the wallower is not a simple matter (Plate 12). The two generations of both coach bolts and wooden pegs are indicative of a reduction in diameter.

It might be thought that such a reduction in size would enable the gear to turn faster, but, if so, there would need to be fewer cogs on the wallower than previously. This modification has maintained the same number of cogs, thus keeping the ratio of the gears the same. What has altered has been the pitch. There appears to have been a reduction in the pitch circle diameter of approximately 2ins. This suggests that the pitch of the

wallower cogs has been reduced from approximately  $4\frac{1}{4}$ ins. originally, to the present 4ins.

PLATE 12 Detail of wallower
