AN ARCHAEOLOGICAL SURVEY OF THE REMAINS OF WATER MILLS AND ASSOCIATED FEATURES ON THE RIVER HONDDU IN SOUTH POWYS

Clementine Lovell

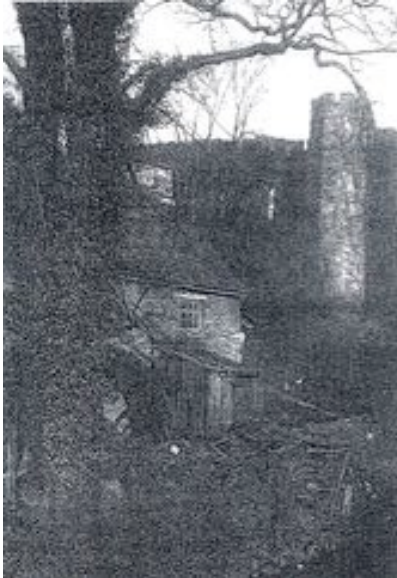
An old photograph shows that the wheel was undershot, confirmed by the level of the leat which is not high enough to have fed the wheel from above. The wheel is no longer there, but it seems that the line of the leat is still preserved in the line of a wall. Upstream the position of the stone-walled leat is still clearly visible as a steep-sided ditch passing under Castle Bridge. The position of a weir feeding the leat is shown on the Ordnance Survey map of 1887, but the area has been much altered by the rebuilding of the bridge, and detailed surveying

PLATE 1 Castle Mill c.1920; the appearance of the water wheel proves that it was undershot (source: Brecknock Museum)

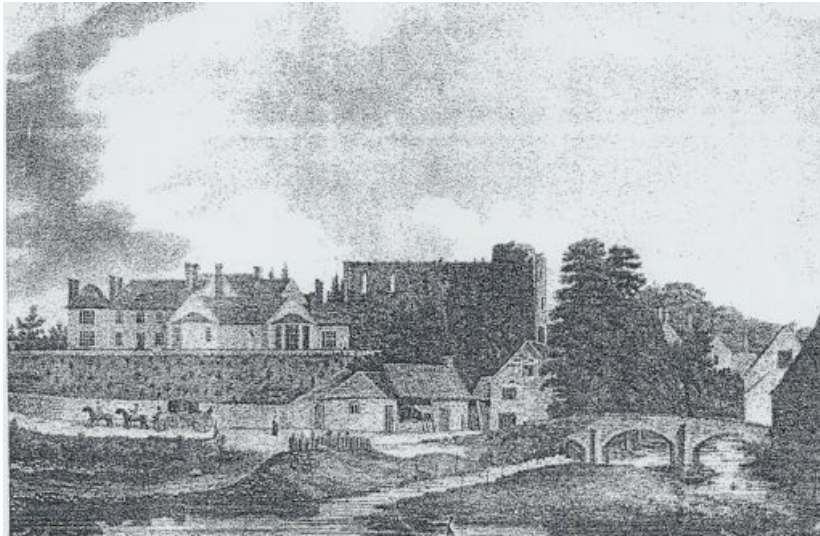
in the river failed to find any trace of it. South of the mill, a C19th print shows that the tailrace flowed into the River Usk; but the line had been destroyed by the rebuilding of Honddu Bridge, and it is impossible to see exactly where it would have been.

PLATE 2 C19th print showing position of tailrace (source: Brecknock Museum, artist unknown)

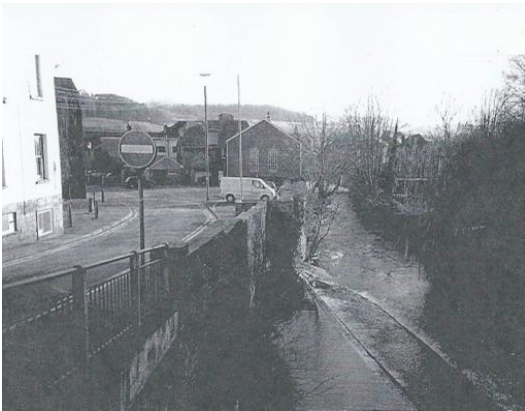
a photograph taken during the 1979 floods shows a slate roof in poor condition. The site is now a car park, but the stone-built, concrete-topped weir is well preserved, and a sluice controlling the entry of water into the leat was still open as recently as 1998. As at Castle Mill, the wheel must have been undershot as the potential fall of water is very small.

PLATE 3 The site of the saw mill and the weir (1988)

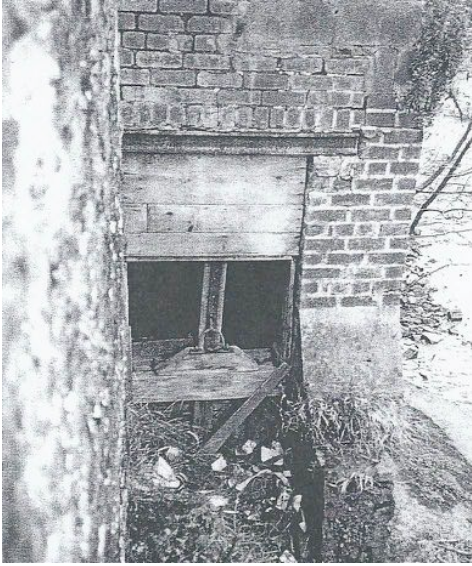
PLATE 4 The water intake in 1998: the perforated iron strip and peg would have held the gate open (source: A. Dowling)

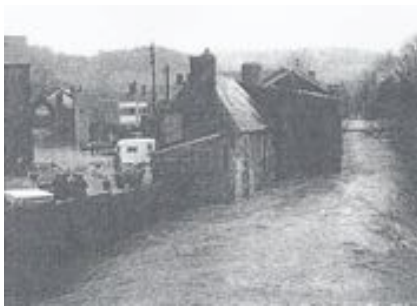
PLATE 6 Photograph from 1979 showing saw mill in derelict condition

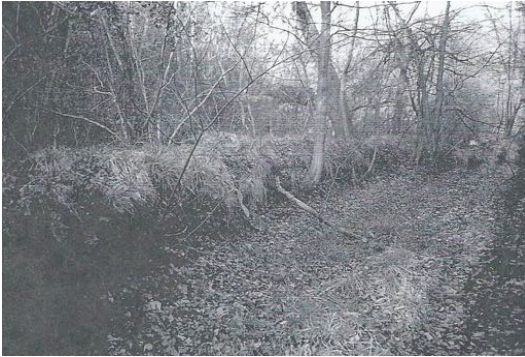
The mill leat itself is still clearly visible, and at 2 metres wide is considerably wider than most leats I have surveyed (Plate 7). It is embanked by an impressively-built stone wall, and is 7 metres above river level where it reached the mill pond. There is a weir, but the leat immediately downstream from it has been destroyed where the road has been straightened. The weir has clearly been rebuilt since the road alterations, and water must have been piped under the road to the existing leat. There is an intake next to the weir, now fully blocked but with railings around it clearly intended to prevent blockage; but there is no sign of a pipe (Plate 8).

PLATE 7 Leat for Struet Mill

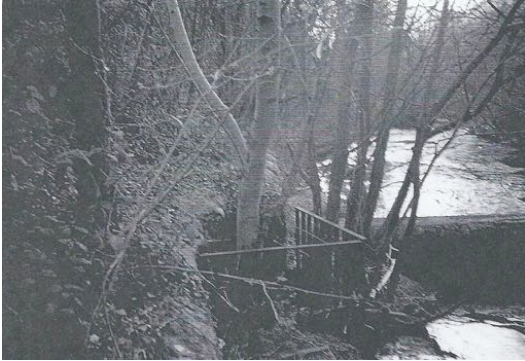
PLATE 8 Struet Mill intake behind railings

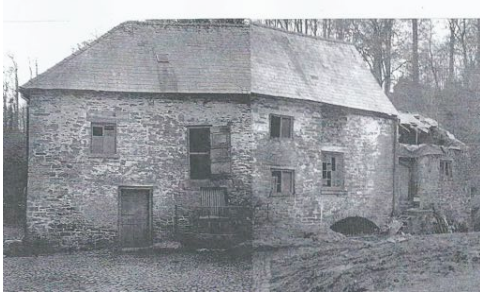
PLATE 9 North-East face of Priory Mill (Despite the appearance of the composite photograph the roof line is straight)

The appearance of the building suggests that it is C19th in origin, and this was corroborated by Mr Williams. The mill appears to have been built in three phases, as can be seen from the evidence of straight joints, immediately to the south-east of the arch (Plate 9) and at the north-east side of the two doorways (Plate 10); this shows that the mill started out as a simple rectangular building, with the external wheel on the north-west gable (marked A in Figure 4). Sometime later another building (B) was added to cover the wheel, and a single-storey building (C) beyond served as a kiln. Later again a south-west wing (D) was built, making the whole plan L-shaped. The windows provide further evidence of different dates; the original building has simple two-pane windows and stone lintels, whilst the section over the wheel and the south-west wing have multi-pane windows, with low arches over openings in the south-west wing. The roof of this wing extends over part of the original building, exposing part of the original wall-plate. The whole mill might have been re-roofed, retaining the original roof trusses, but Mr Williams had no memory of alterations since his arrival in 1919. There was no cart entrance, and carts must have been loaded from the upper doors.

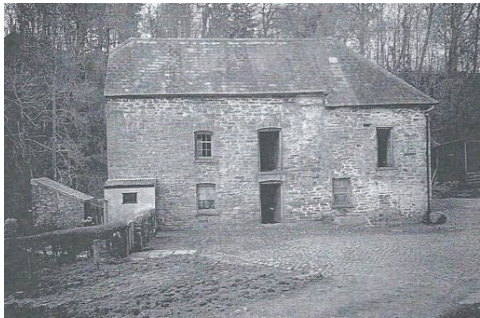
PLATE 10 The south-east face (Note: the join is on the right hand edge of the two doors, not on the roof line change: the wall-plate from the original building can be seen below the later roof)

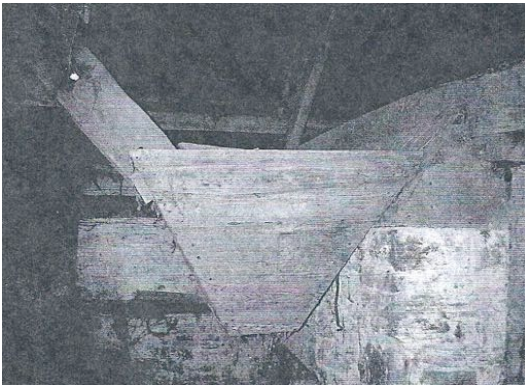
PLATE 11 The sloping beam to the left of the hopper is part of the earlier roof structure

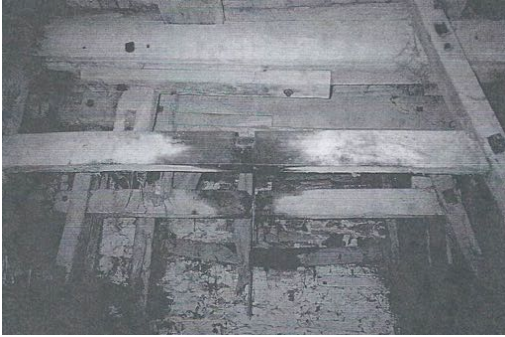
PLATE 12 Oil staining as evidence for a rotating shaft

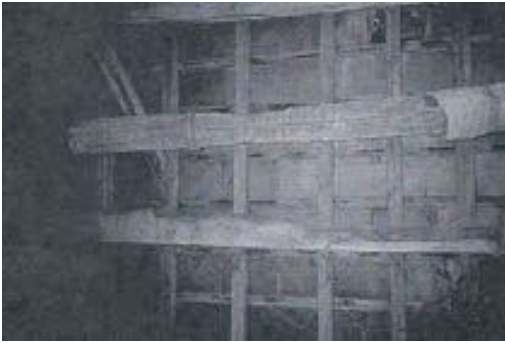
PLATE 13 Wear marks from a chain

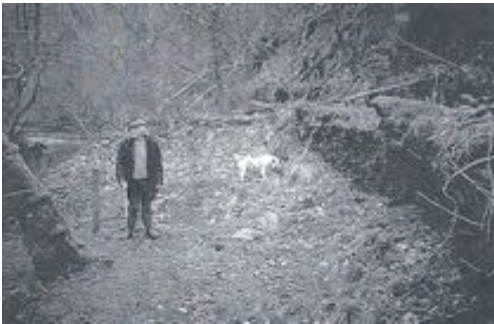
The wheel has gone, but the height difference between the arch letting water in and the tailrace arch confirms that it was overshot. The ground level would have been lower than today to allow space for the 3 metre diameter wheel. The water entered from a long, narrow mill pond which was filled in long ago, although the edging stones are still visible on one side. Further away the leat is apparent, leading to the remains of its sluice and weir. The weir and a bridge alongside it are shown on the 1887 Ordnance Survey map (Figure 5) and in two C19th prints. The bridge was derelict by the time Mr Williams arrived in 1919, and the weir has not been maintained since the mill ceased work in 1938. One edge of the weir remains to show that it was 3 metres high; the rest has been destroyed by floods and erosion.

PLATE 14 The sloping edge in the background is the only remaining evidence for the weir. Mr Williams gives an indication of scale

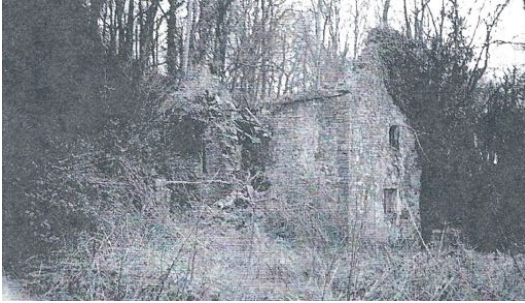
PLATE 18 Llandefaelog Mill in approx. 2000

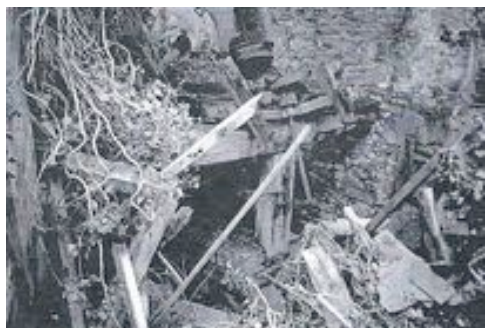
PLATE 20 Conditions in Llandefaelog Mill in 2000

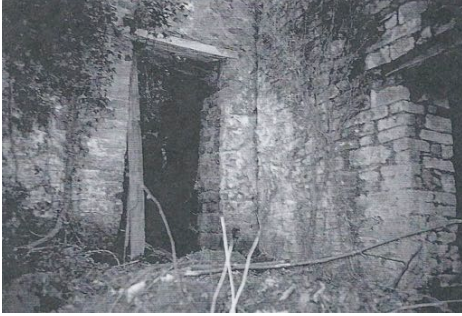
PLATE 21 The join between the two walls is evidence that the kiln building (on the right) was a later extension

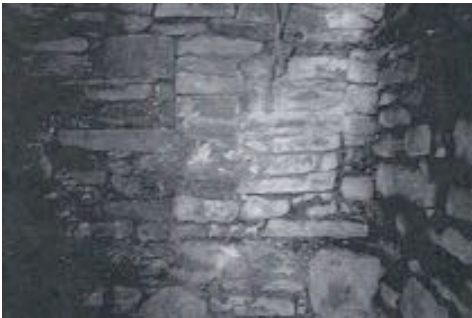
PLATE 22 The blocked window indicates that this was once an outside wall

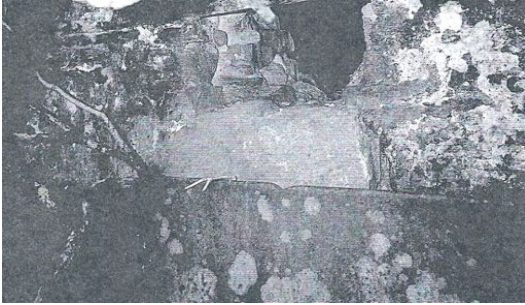
PLATE 23 The dip in the 'sill' and in the tank edge below are evidence for a rotating pivot controlling the flow of water from the tank

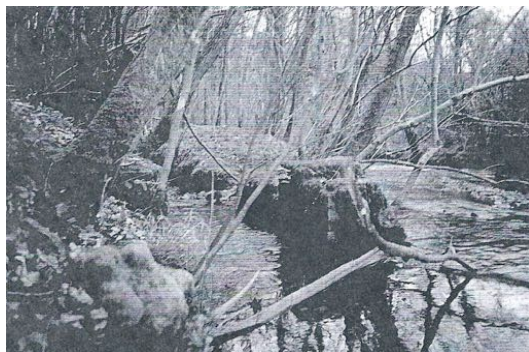
PLATE 25 The stone abutments of the sluice leading to the leat, with slots for the gate evident in the stone
